**ULTIMATE HORIZONTAL SHEAR STRENGTH OF
PRESTRESSED SPLIT BEAMS**

NAVAL CIVIL ENGINEERING LABORATORY

Technical Report R-707

S. B. Nosseir and R. N. Murtha

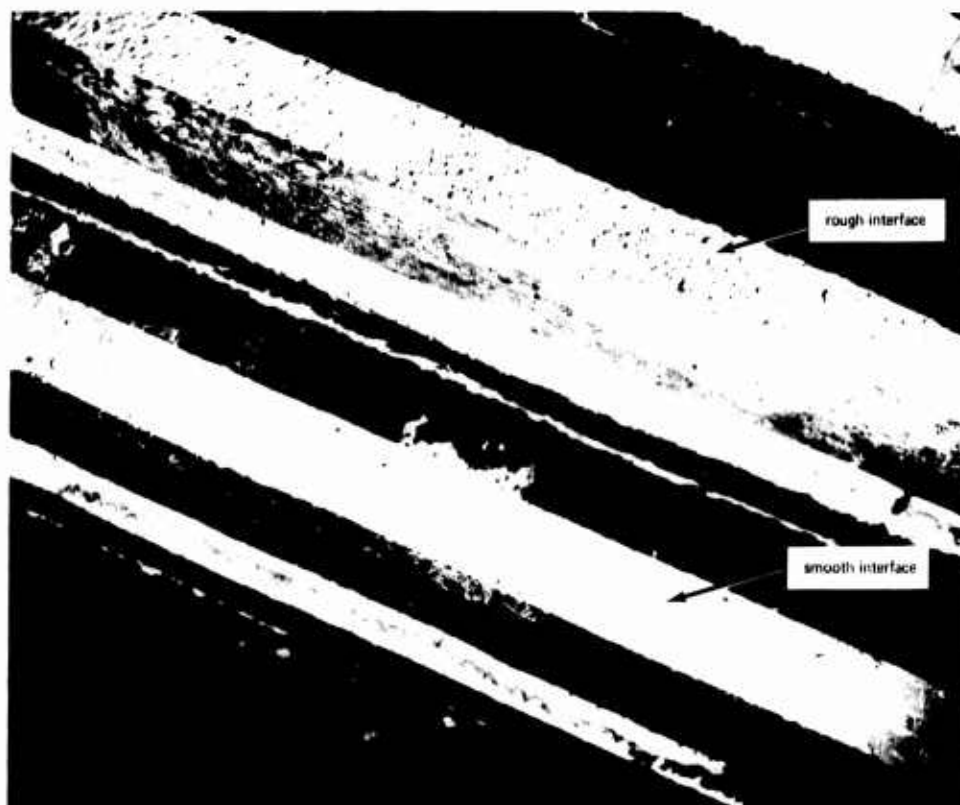
Figure 6. Beams showing rough and smooth interfaces.

or a rough surface using a wire brush. The relative roughness can be visualized by comparing the finish of the two interfaces shown in Figure 6. The top surfaces of all cast-in-situ beam parts and all control cylinders were troweled smooth.

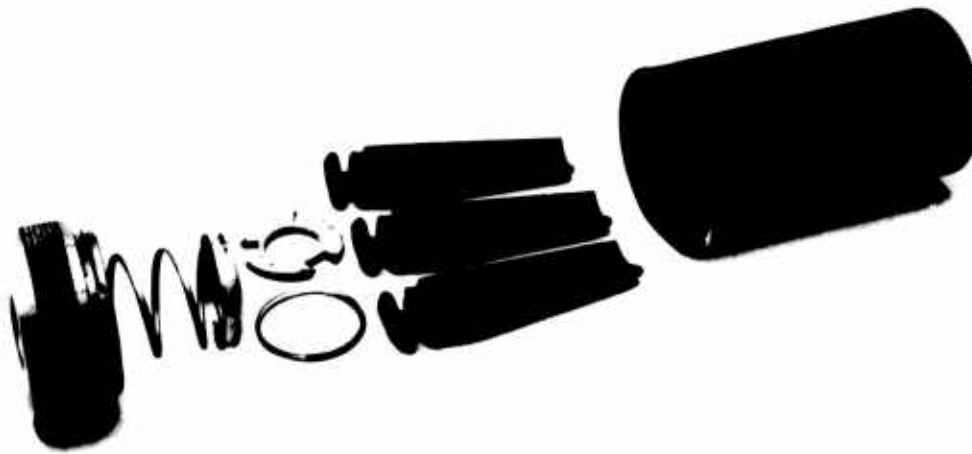
Figure 8. A disassembled grip.

At the beginning of the prestressing operation, grip no. 1 was loosened so that its gripping action would not take place at the initial stage of the tensioning. When the pump was operated, the travel of the ram was resisted by grip no. 2 at one end and grip no. 3 at the other end of the beam (Figure 7a). The thrust was transferred from the jack to grip no. 2 through a washer, load cell no. 1, the jacking frame, the test beam, to load cell no. 2, in that order. A 1/2-inch bearing plate embedded in the beam (Figure 7b) was used to distribute the thrust transmitted to the beam through the jacking frame. A similar plate was used at the unjacked end for the same purpose. The tensioning was temporarily stopped when the reading of the strain indicator corresponded to a thrust of about 10 kips. Grip no. 1 was then tightened until its gripping action started to take place. At this stage, no shims were used, that is, grip no. 1 was directly in contact with the bearing plate of the jacking beam end. The jack pressure was then released. As a result, load cell no. 1 indicated a zero thrust, that is, there was no tension in the part of the strand between grip no. 3 and grip no. 1. Load cell no. 2, however, indicated that the tension trapped in the strand between grip no. 1 and grip no. 2 was, on the average, 6.5 kips. The drop of the value of thrust from 10 kips to 6.5 kips, or the prestress loss, is due to anchorage take-up at grip no. 1.
